TECHNICAL REPORT REMR-CO-5

STABILITY OF DOLOS OVERLAYS FOR
REHABILITATION OF DOLOS-ARMORED
RUBBLE-MOUND BREAKWATER AND JETTY
TRUNKS SUBJECTED TO BREAKING WAVES

Robert D. Carver, Brenda J. Wright

Coastal Engineering Research Center

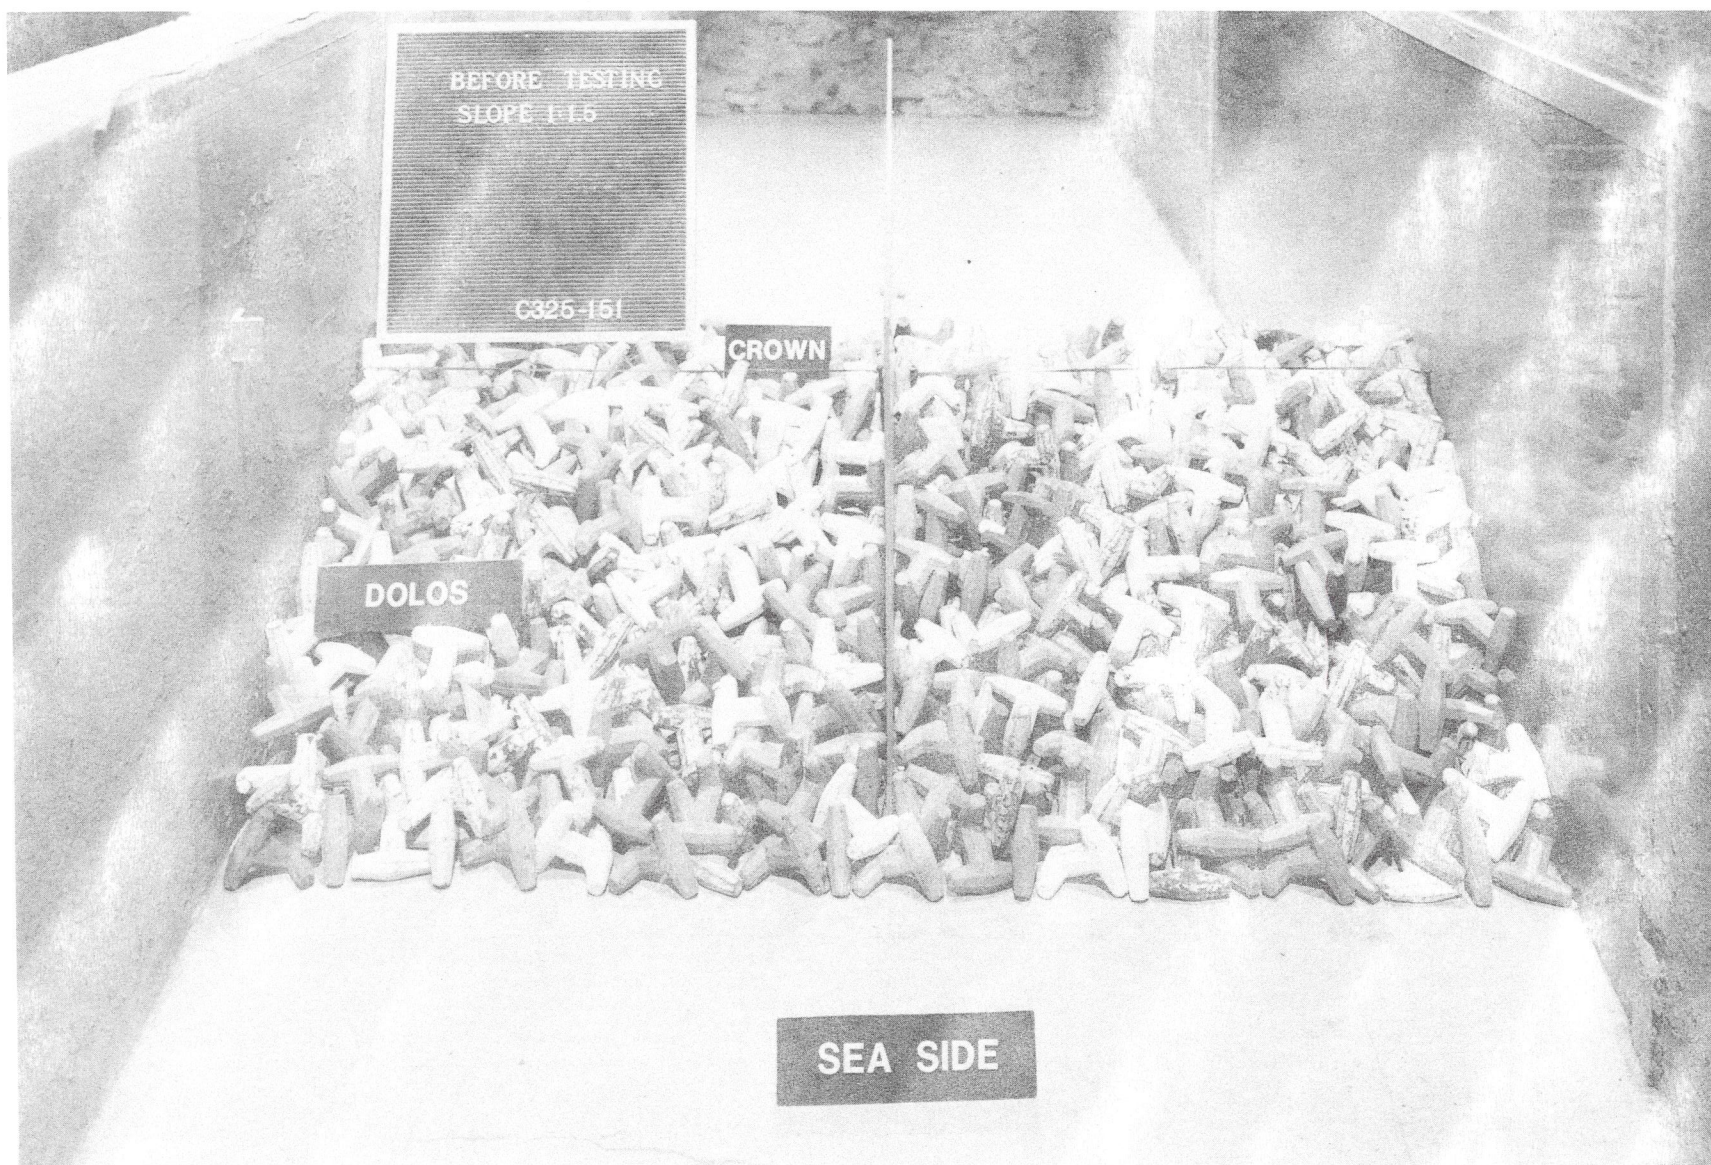
Photo 2. Sea-side view of a typical test section before wave attack at a 1V-on-1.5H-sea-side-structure slope; $W_a = 0.589 \text{ lb}$

17. All stability tests were conducted on sections of the type shown in Figure 1 and Photos 1-4. Sea-side slopes of 1V on 1.5H and 1V on 2H were investigated, while the beach-side slope was held constant at 1V on 1.5H. Heights of the simulated existing structures (prior to placement of the dolos overlays) varied from 1.0 to 1.2 ft. The height necessary to prevent wave overtopping of the existing structure was determined from slopes and estimated water depths and wave heights to be investigated in determining stability coefficients for the dissimilar armor overlays.

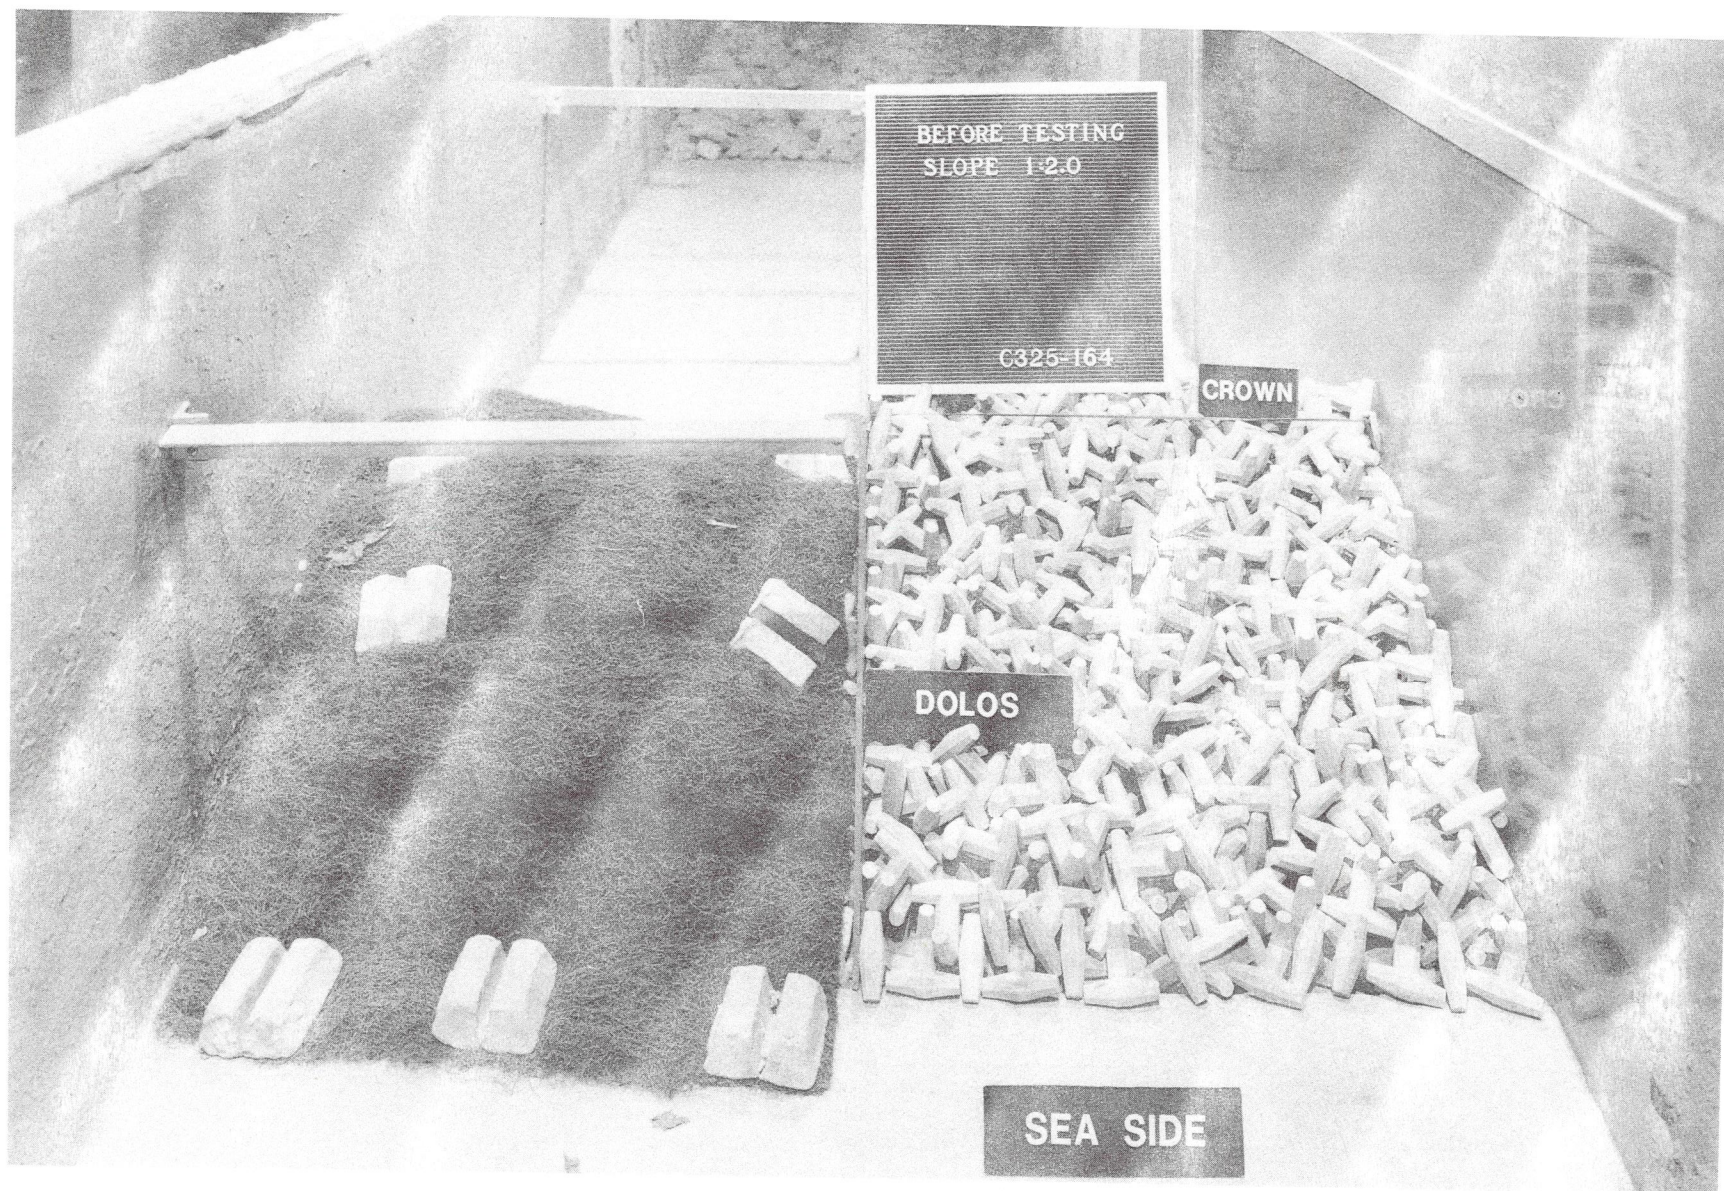
Photo 4. Sea-side view of a typical test section before wave attack at a 1V-on-2H-sea-side-structure slope; $W_a = 0.442 \text{ lb}$

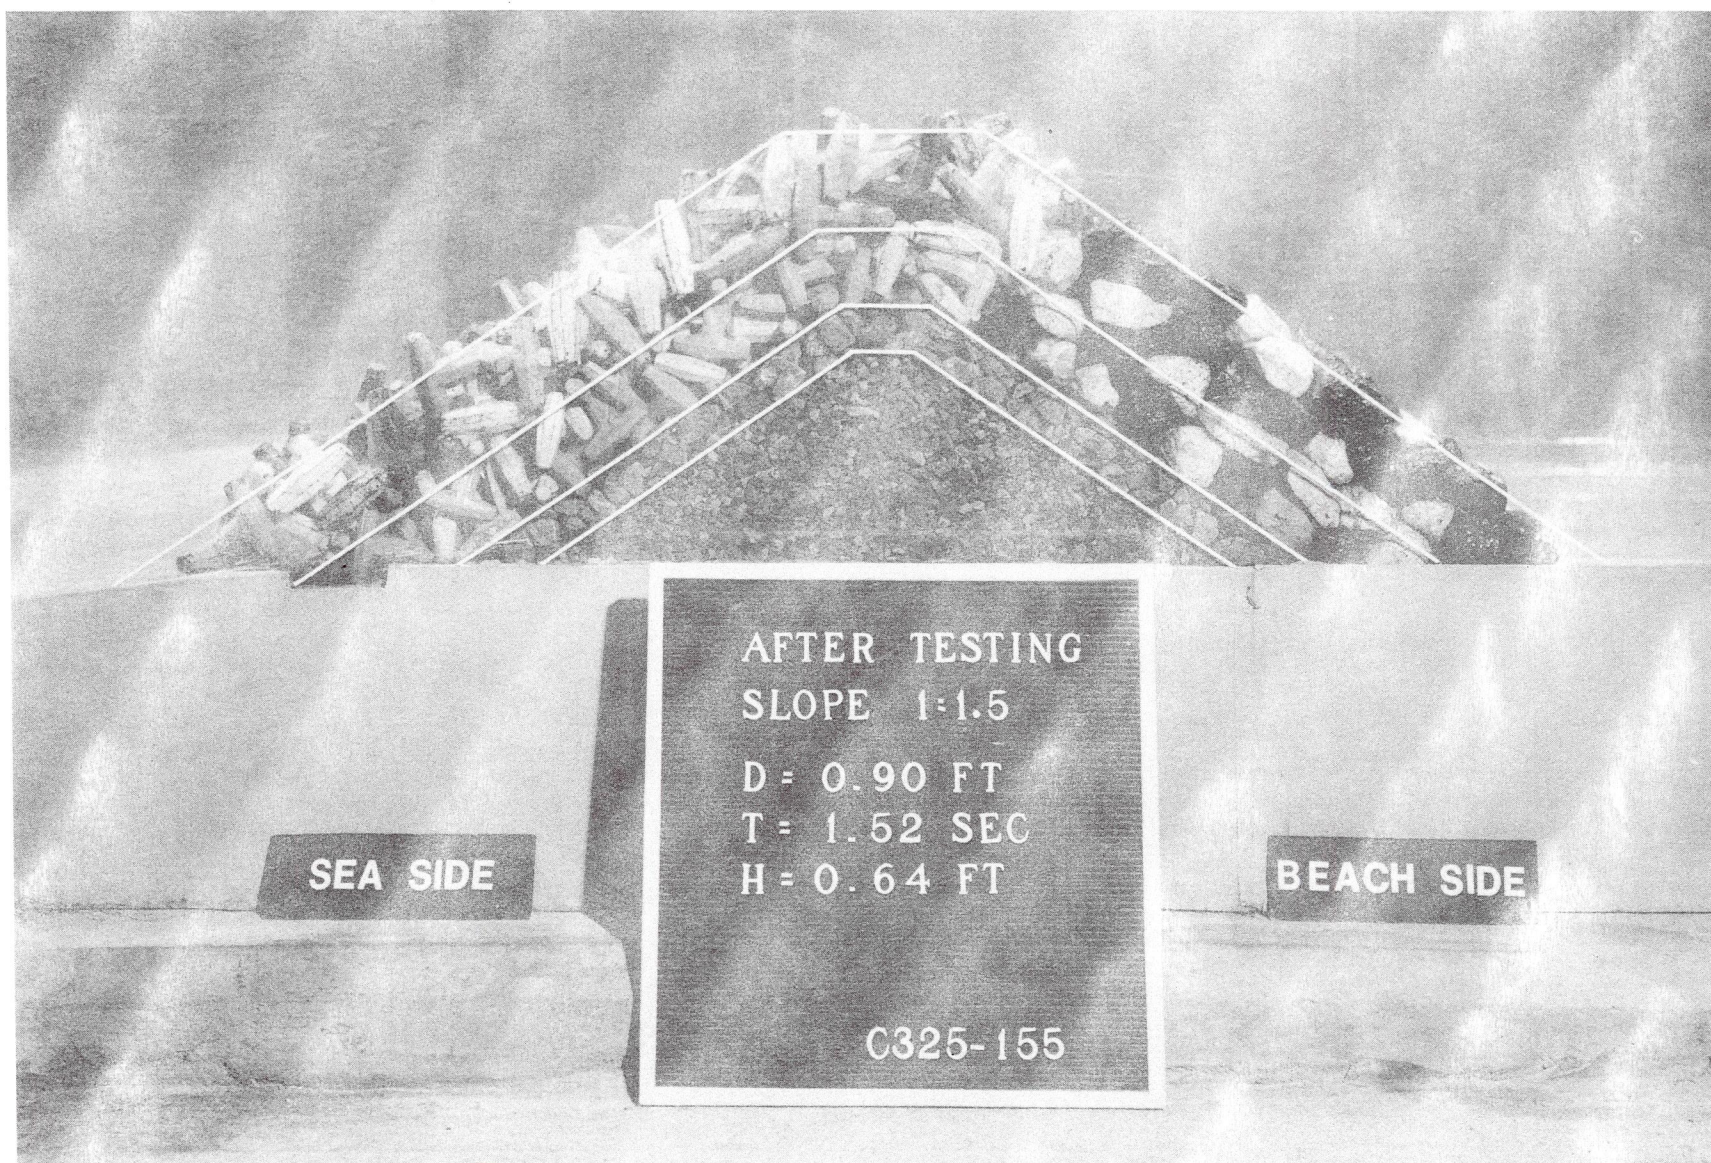
Photo 11. End view after attack of 1.52-sec, 0.64-ft waves; $d = 0.90$ ft;
 $W_a = 0.589$ lb; 1V-on-1.5H-structure slope

Photos 5-20 show typical after-testing conditions of the structures.

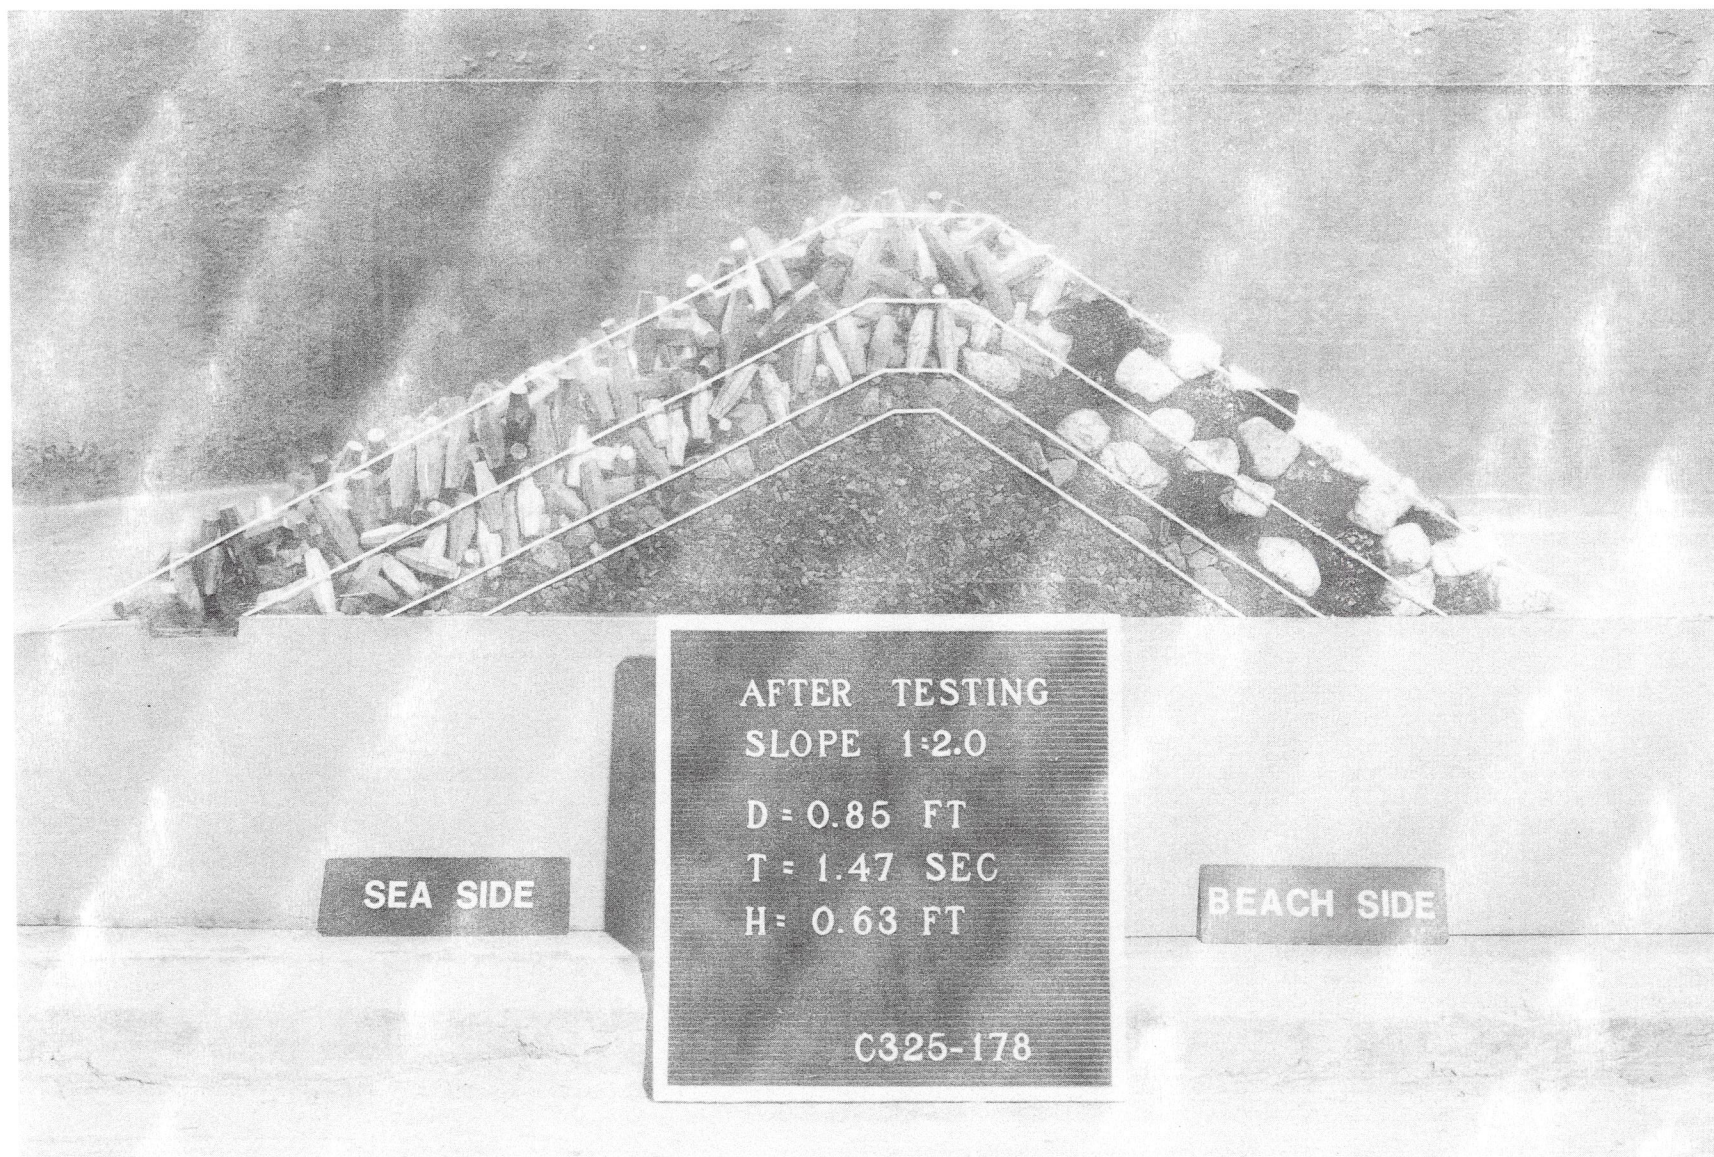
Photo 16. End view after attack of 1.47-sec, 0.63-ft waves; $d = 0.85$ ft;
 $W_a = 0.442$ lb; 1V-on-2H-structure slope
